FIRST TEST ON REAL FIBRE!

This week we were able to get early access to the pilot-sites and a backbone fibre-span we will use to do acceptance-testing with. The span is between Stockholm (Tulegatan) and our new site in Västerås. In the middle of absolutely nowhere a couple of kilometers north of Enköping there is also a amplifier-site.

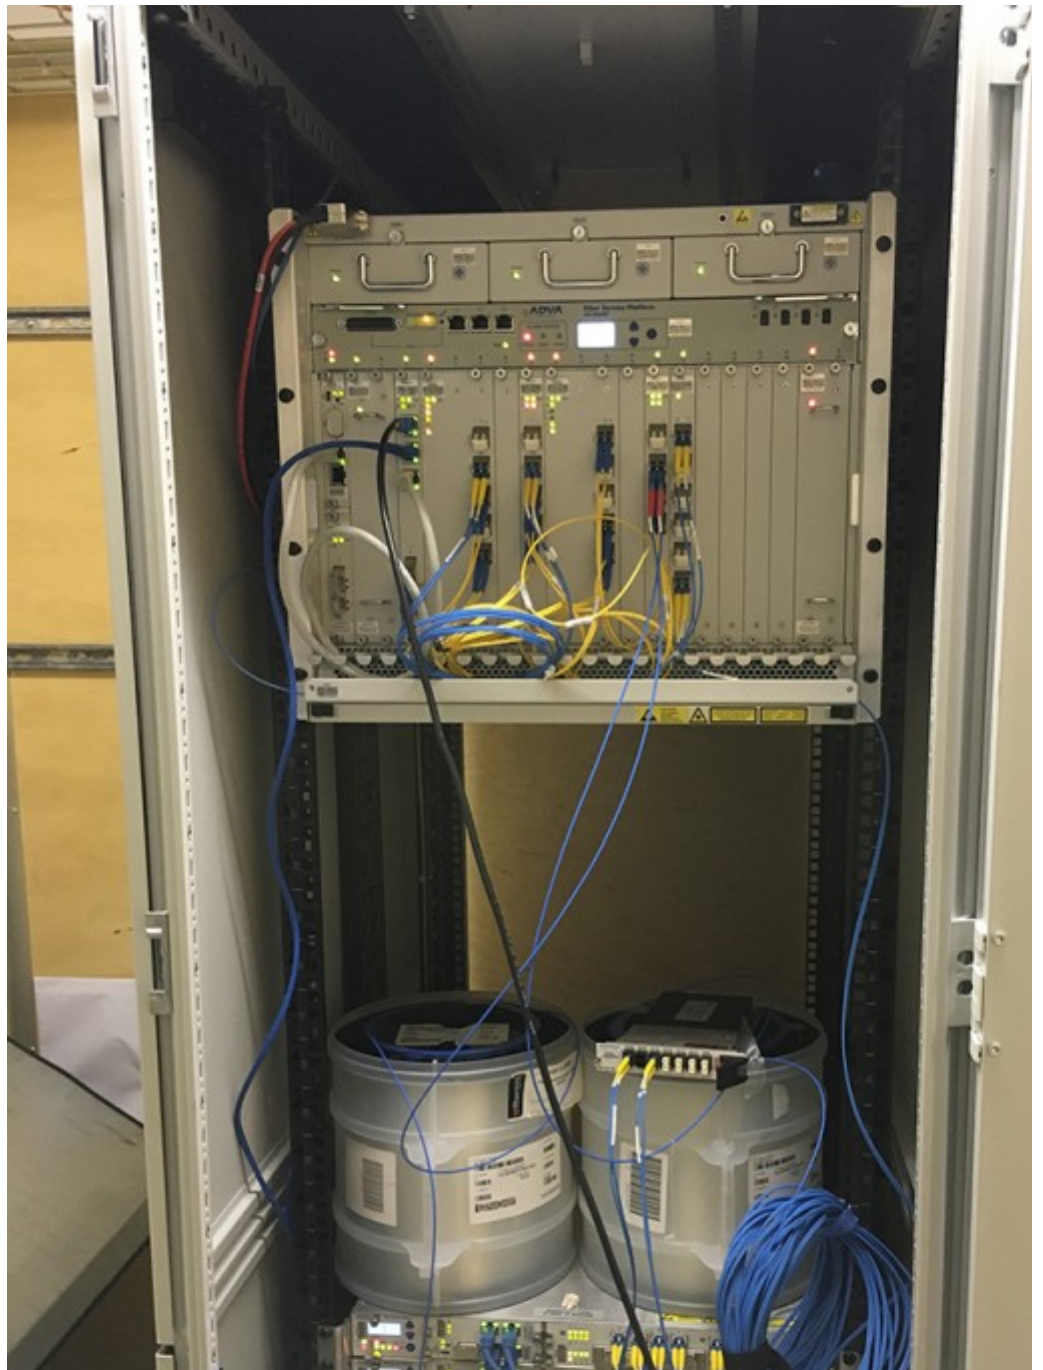
After some struggle with a malfunctioning ROADM-card that didn't pass any light in one direction this span is lit up and traffic is passing through without any problems.

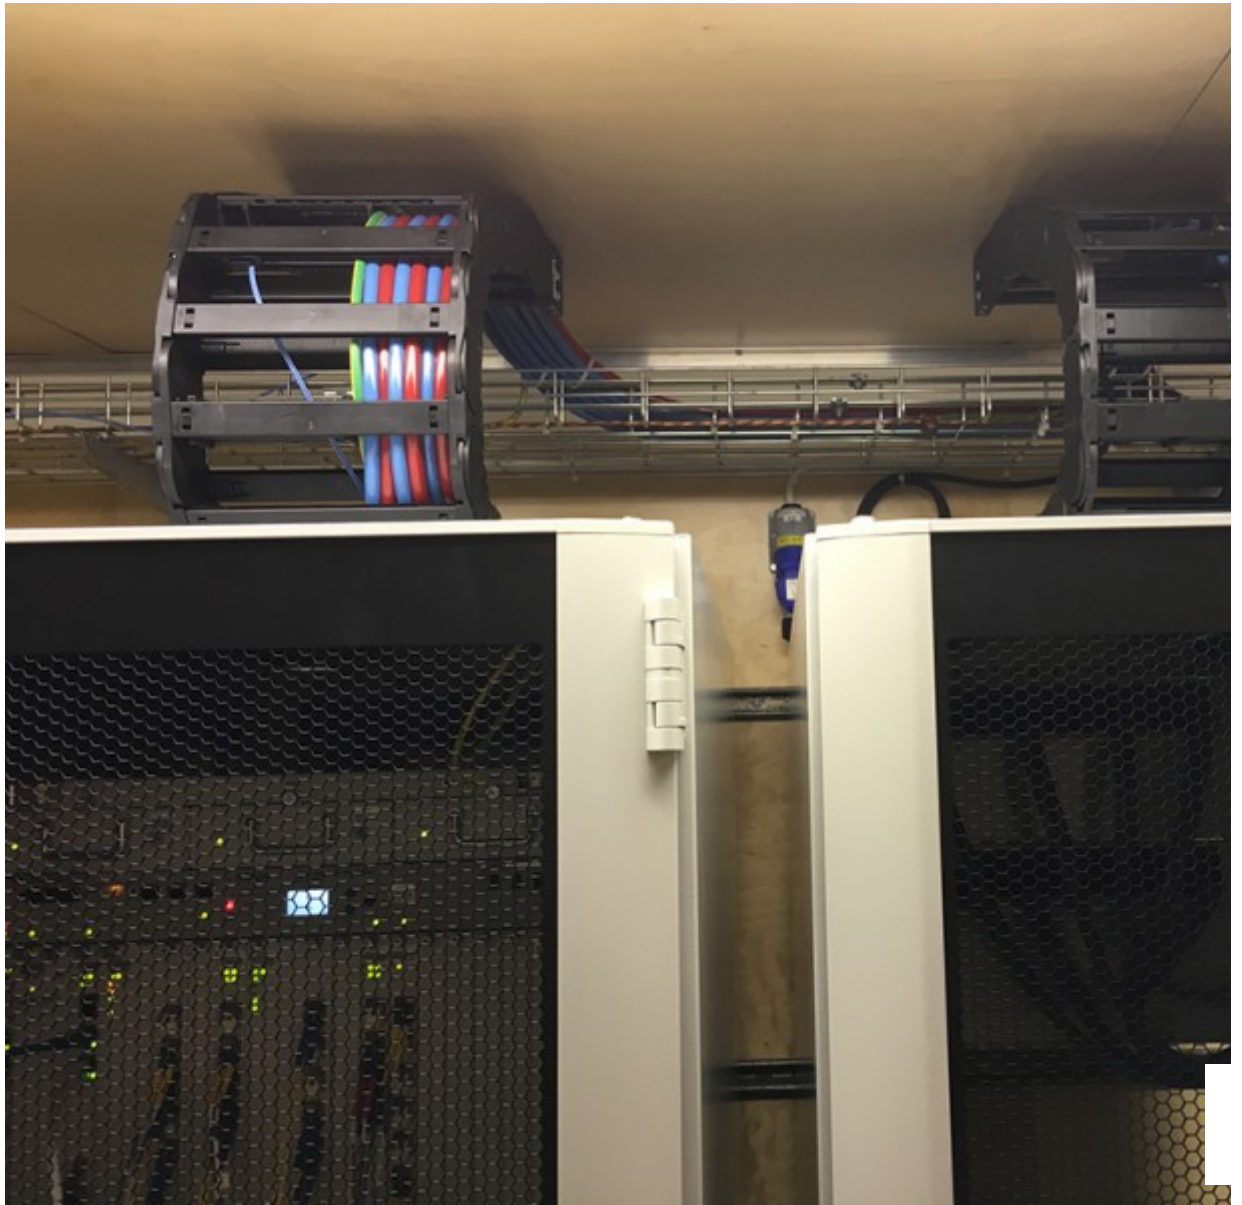
The site in Västerås with ROADM in the top and the router in bottom of the rack. Very temporary installation since the equip is to be returned to Tulegatan in week 48

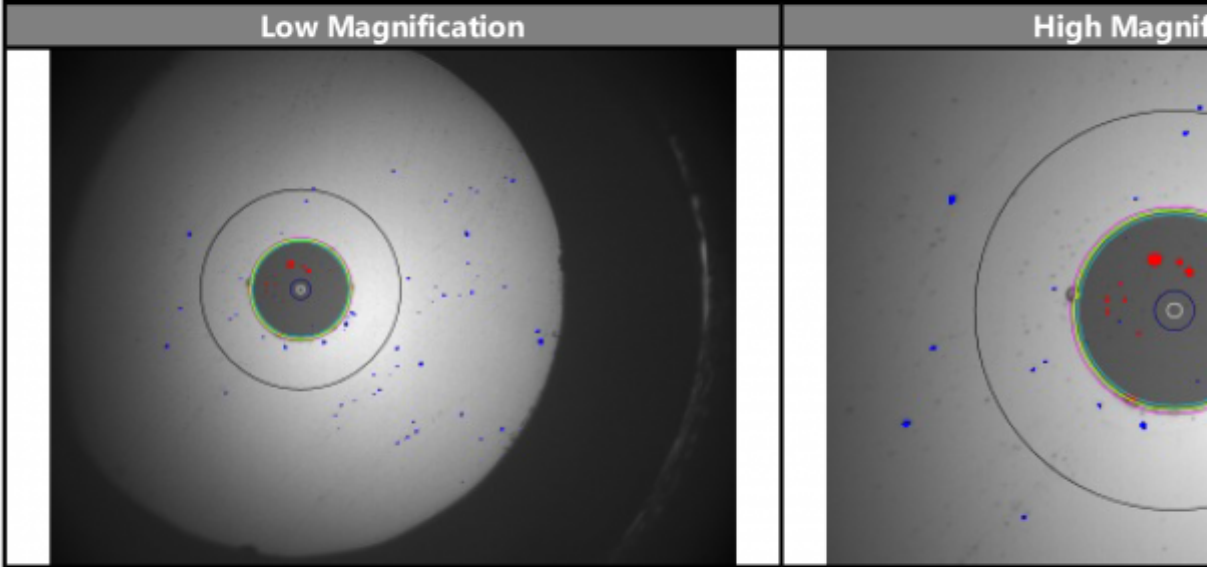
Zone	Defects
Zone A (0 - 25)	PASS
Zone B (25 - 120)	FAIL
Zone C (120 - 130)	PASS
Zone D (130 - 250)	PASS

Analysis Details Zone B: [DEFECTS] Defect > 5 μm, More than 5 defects > 2.0 μm in diam

Connecting fibres with connectors like this on a optical system does not only cause you attenuation but it could also damage both the ODF and the patch since the dirt can over time etch in the glass if unlucky.

When you work with fiber and especially in DWDM-related scenarios cleaning fibers is always of uttermost importance. Dirty connectors cause attenuation which can destroy the optical budget calculated on a link. Blowing in the ODF connectors and wiping the patch-connectors on your jeans is without any doubt the most effective way to make your fibres dirty. To illustrate this i uploaded our initial FiberScope-tests on both connectors in the ODF's and on patches, some of them brand new. Nothing is clean until you have actually scoped it and verified, especially if its fresh from the factory.
