FIRST TEST ON REAL FIBRE!

This week we were able to get early access to the pilot-sites and a backbone fibre-span we will use to do acceptance-testing with. The span is between Stockholm (Tulegatan) and our new site in Västerås. In the middle of absolutely nowhere a couple of kilometers north of Enköping there is also a amplifier-site.

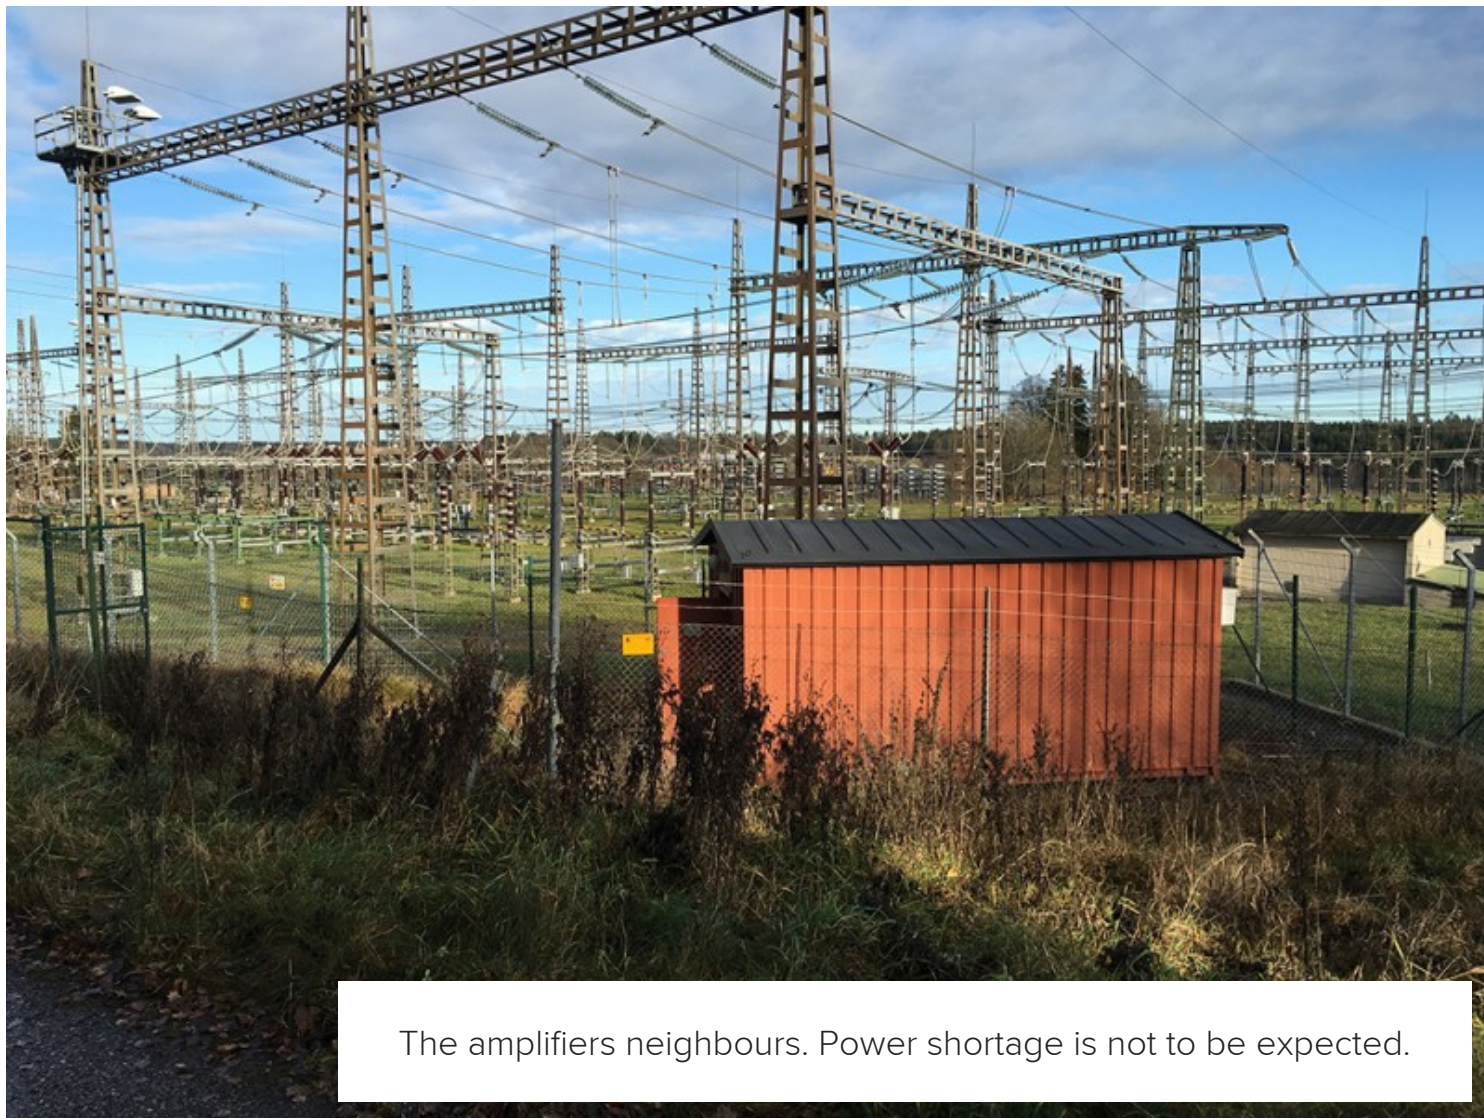
In Tulegatan there is a Juniper MX480 originating a 100G Coherent wave that goes straight into the ROADM (no transponders here as i mentioned earlier), then goes onto the line-fiber. It gets amplified in Enköping and then lands into another ROADM in Västerås straight through to another Juniper MX480 with a Coherent reciever.
